Subjects: Dock and Sea Trials "RTA 1" Catamaran Passenger Ferry
Metal Shark Franklin, LA.

The following was observed during my visit of April 27, 2018

First Catamaran Ferry "RTA 1"

Two (2) 32.0 (m) X 7.7 (m) X 1.35(m)RTA Passenger Ferries

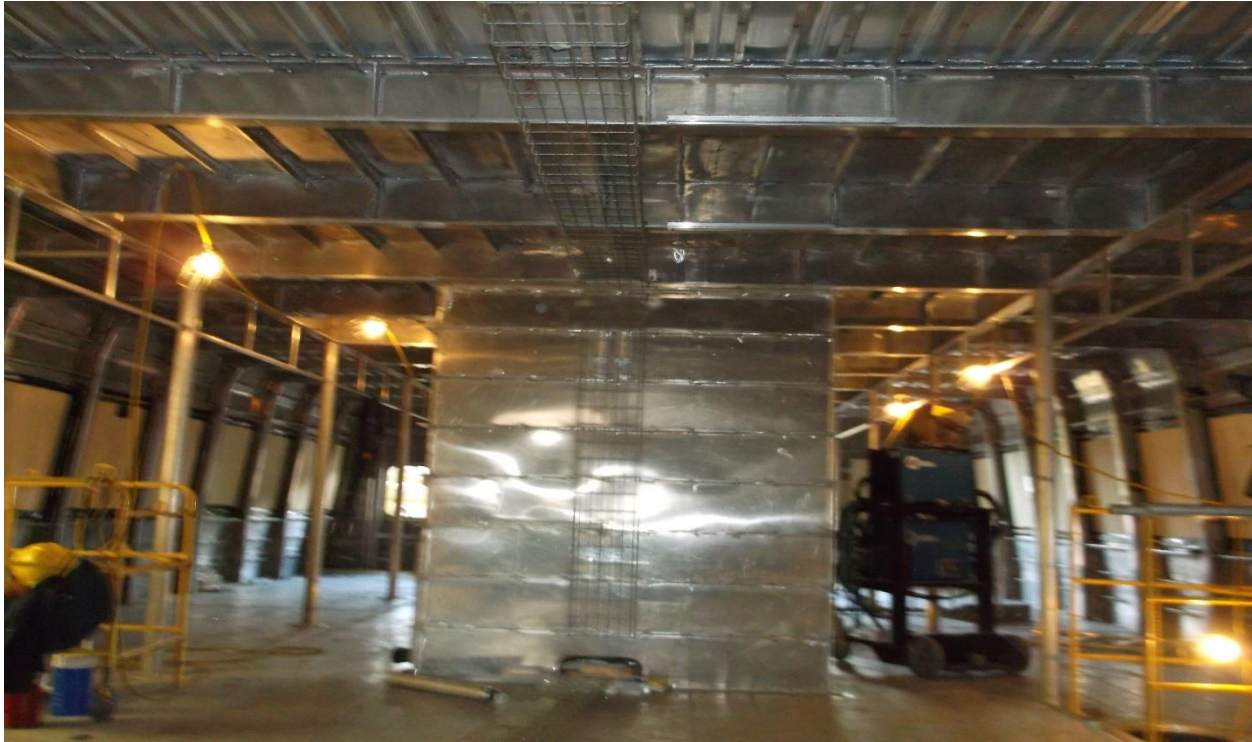
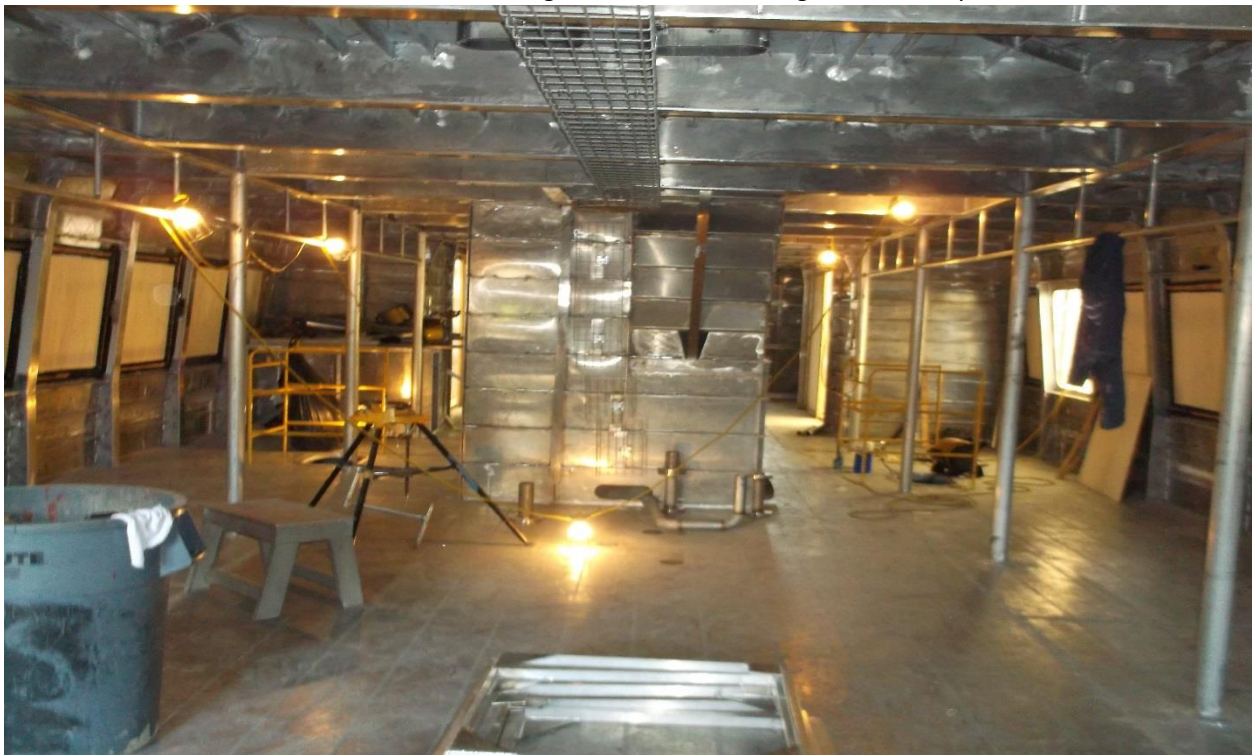
Views inside aft deckhouse looking forward and aft having cable raceways installed

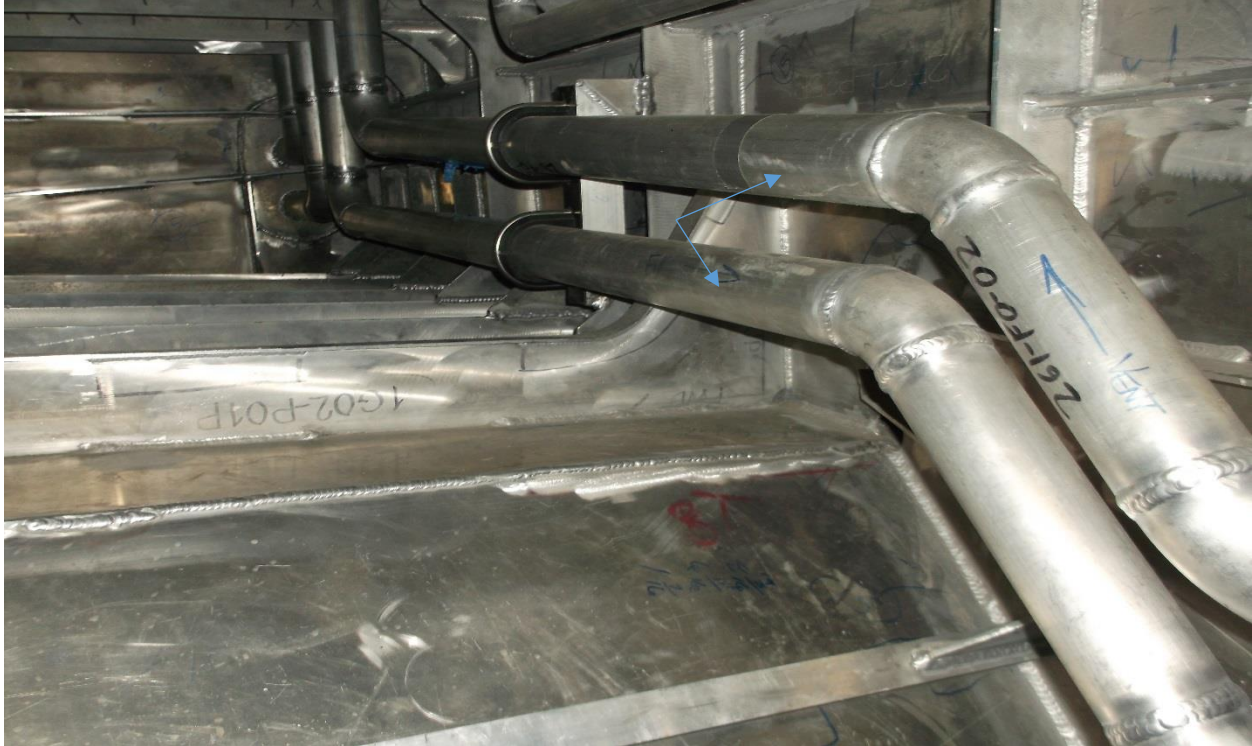
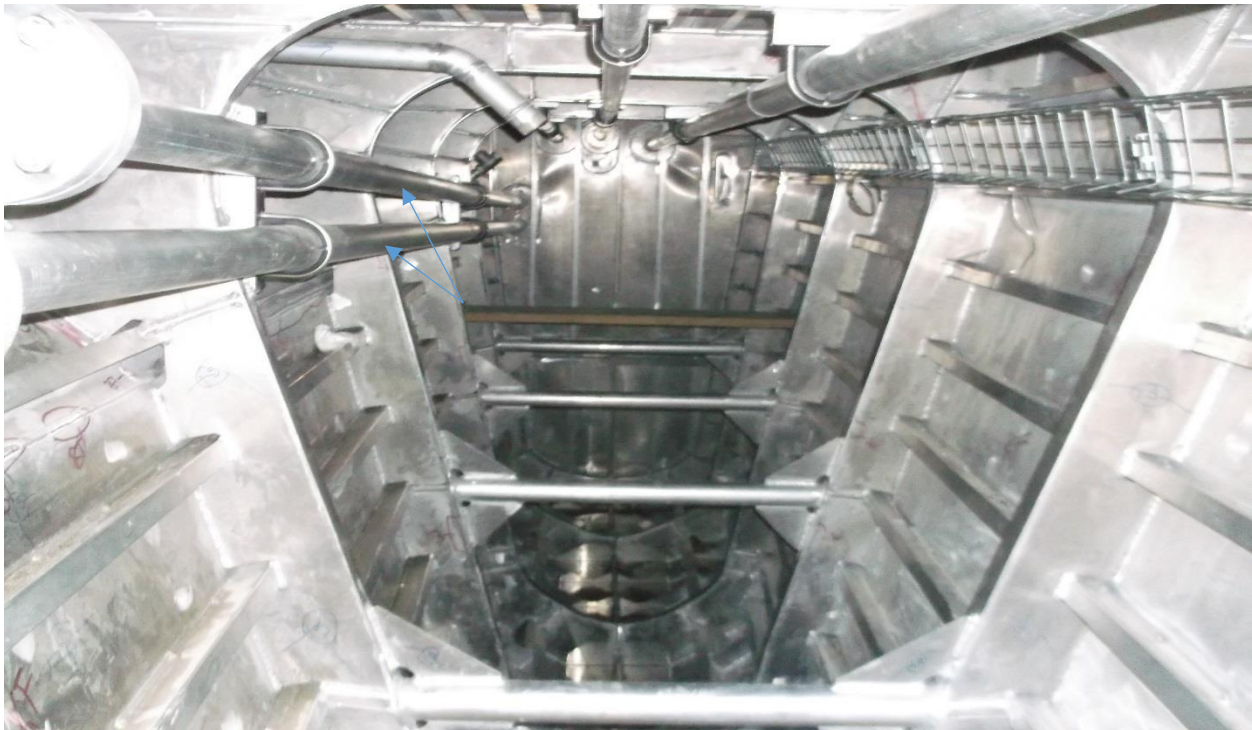
Views inside port no.2 compartment having fuel oil supply and return piping from forward center fill containment station running aft along with vent piping and cable raceway installed

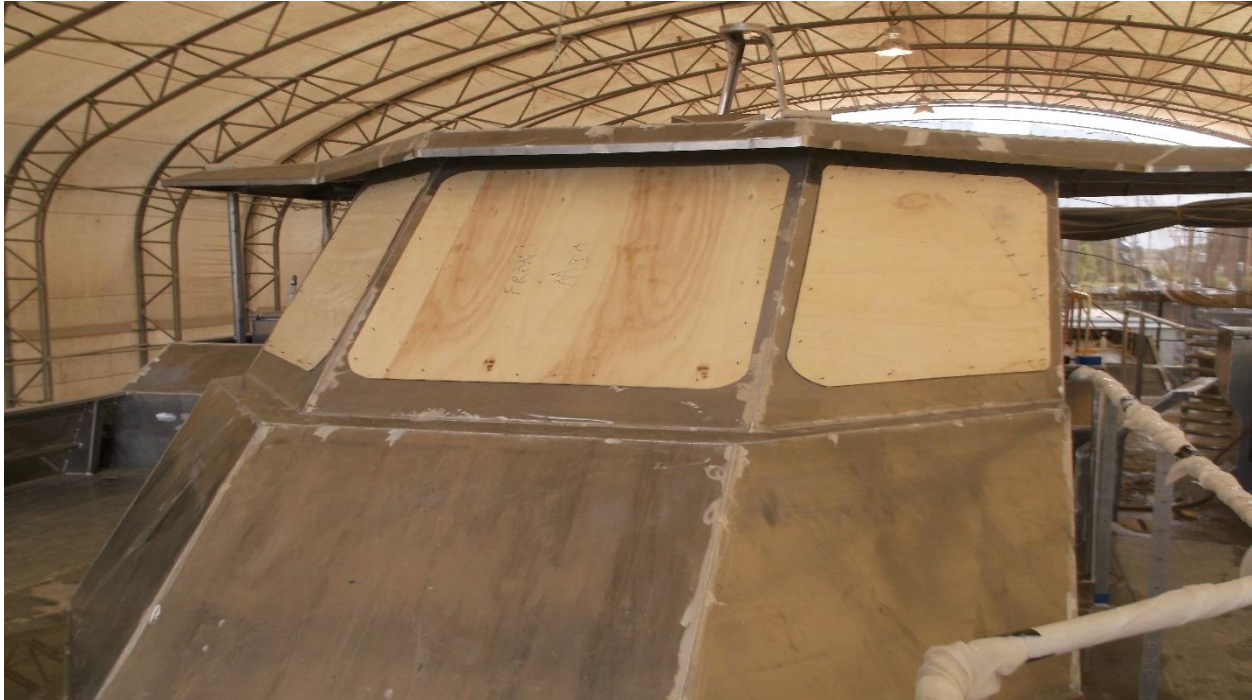
View of forward pilothouse windows and handrails covered for preparation for sandblasting and painting

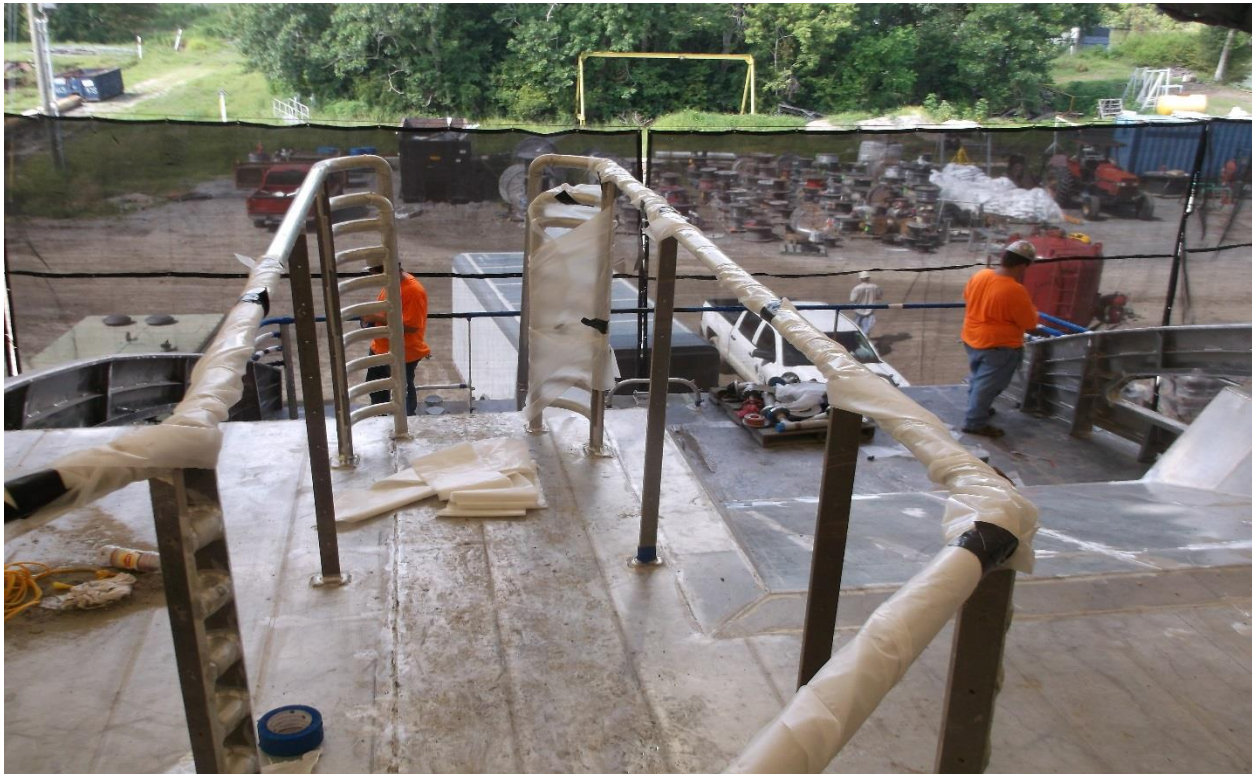
View of handrails on upper deck and lower main deck being covered

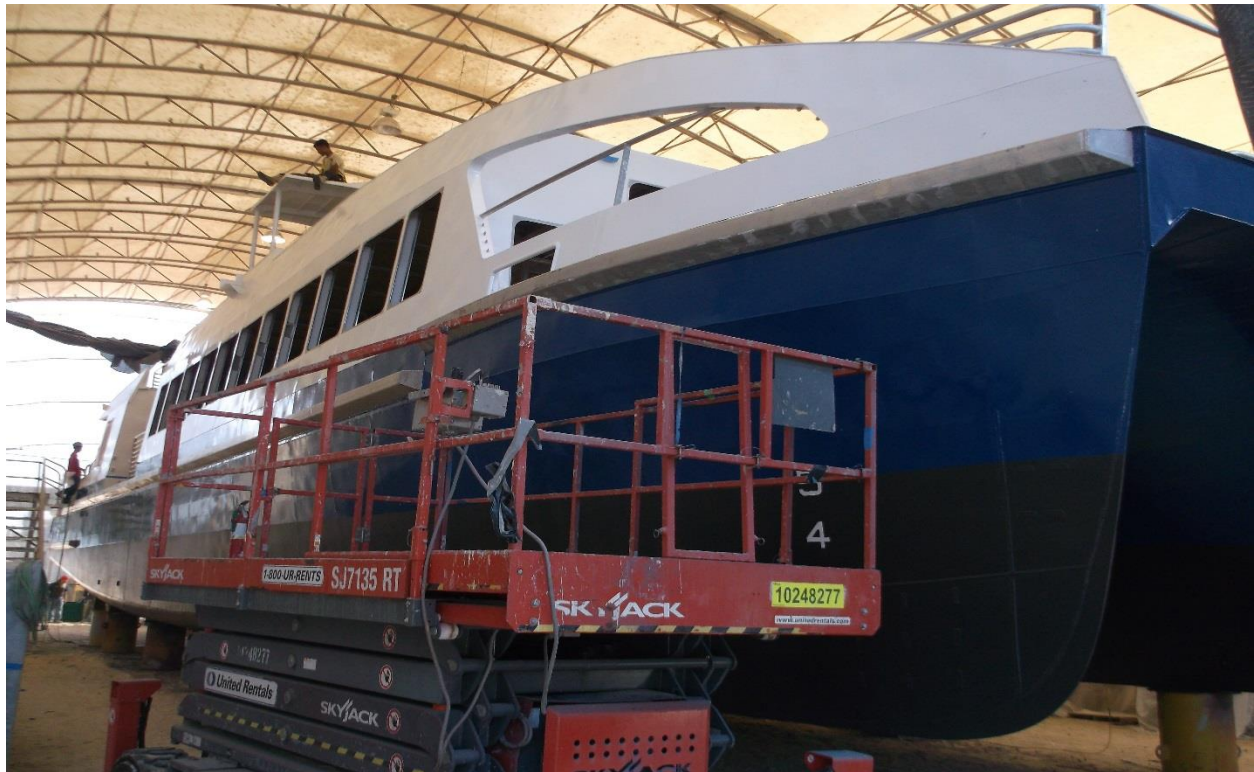
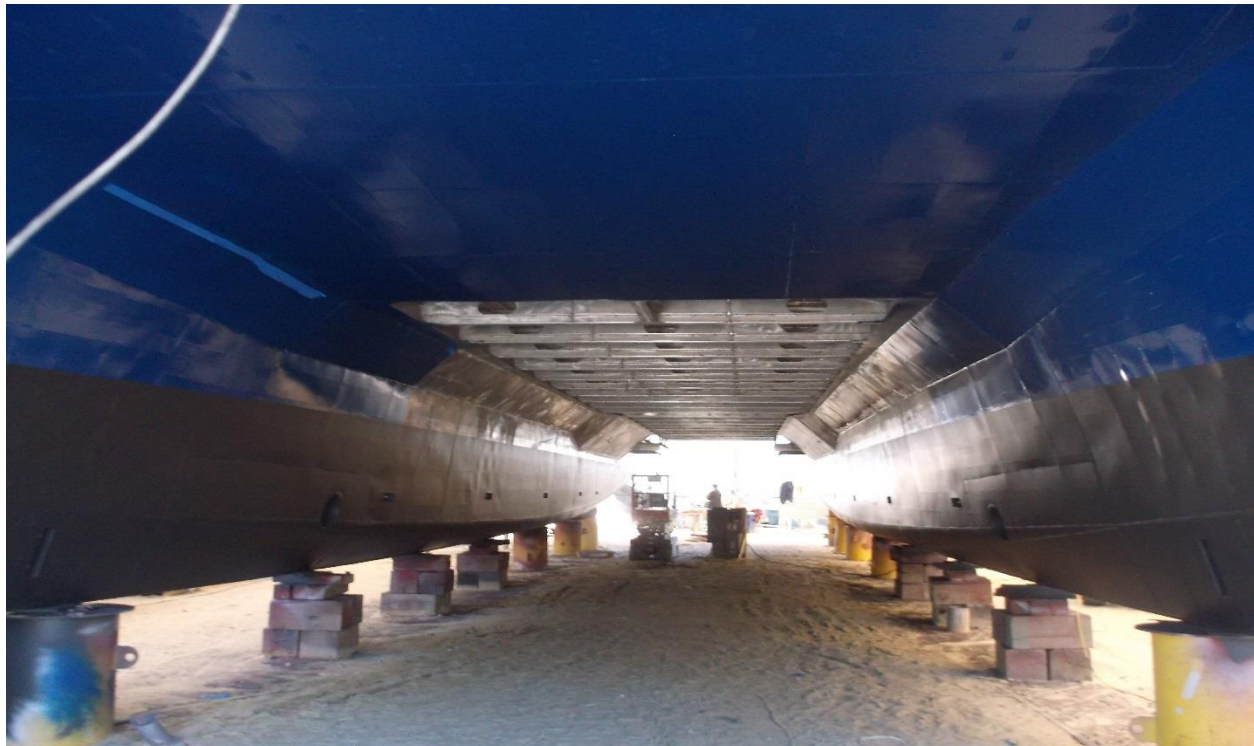
Forward starboard and underside views of "RTA2"

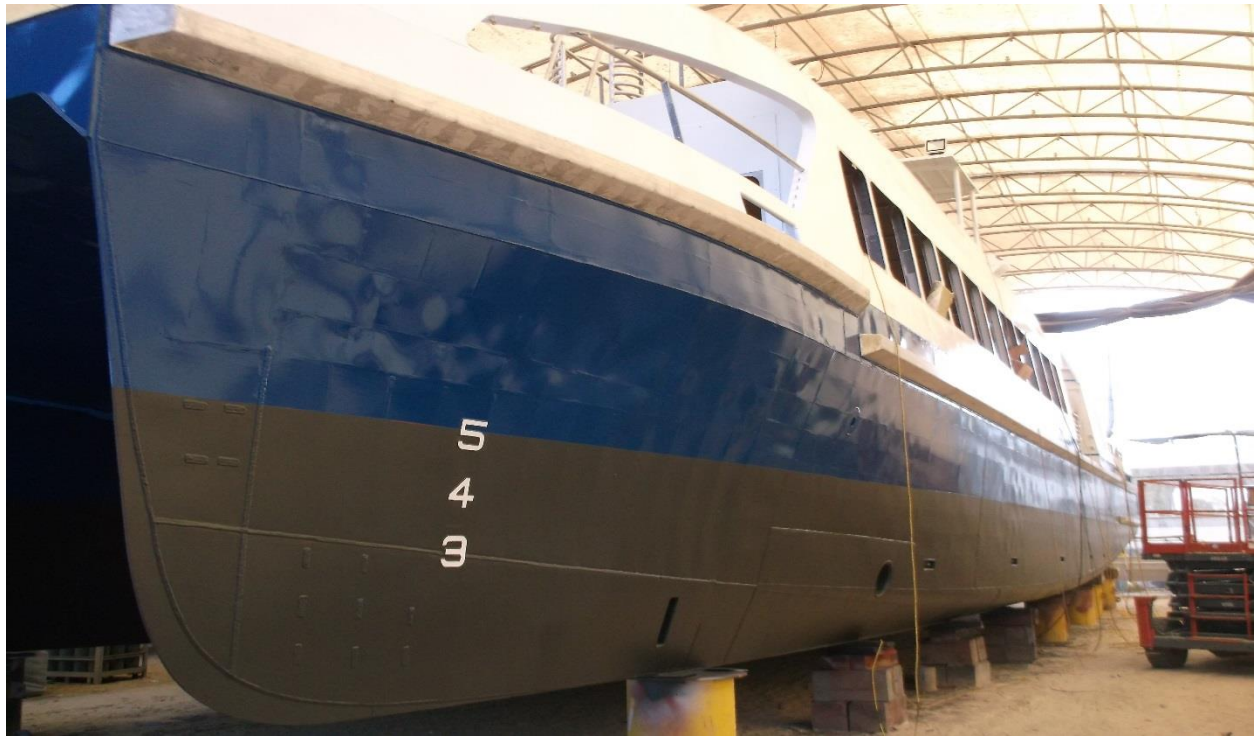
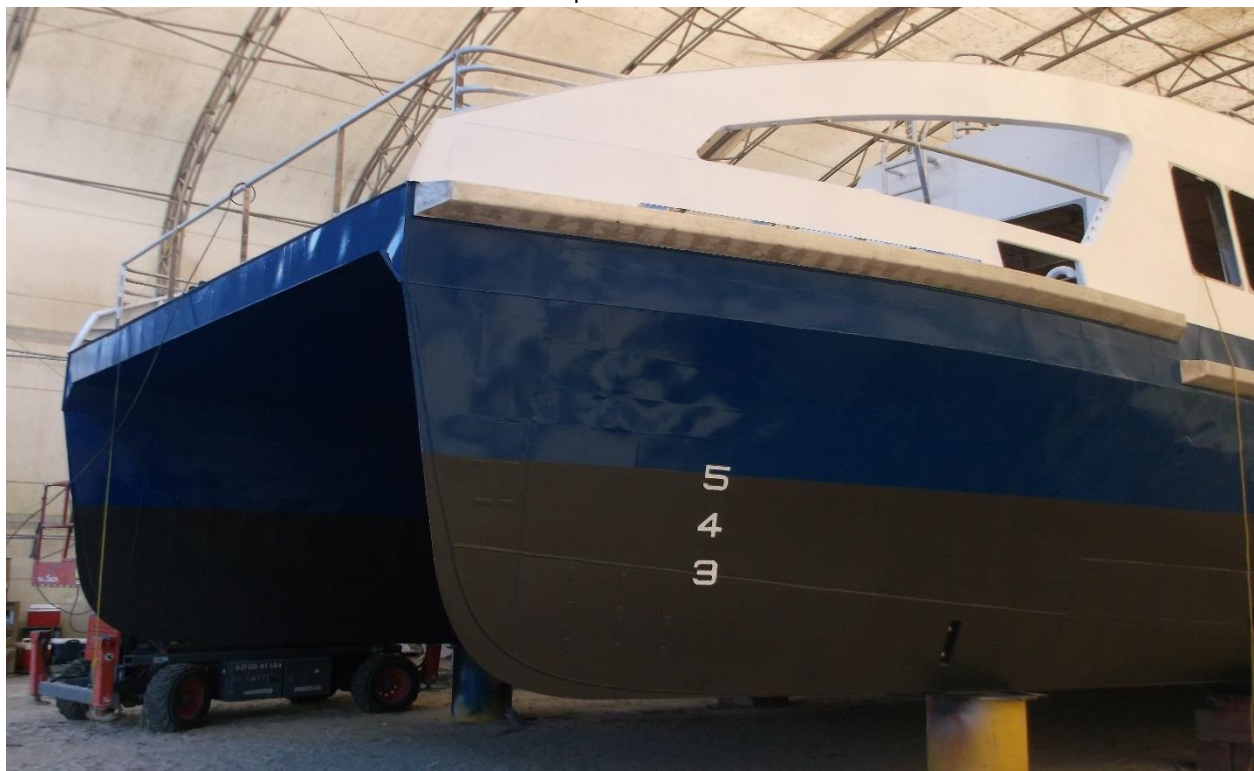
Forward port and side views

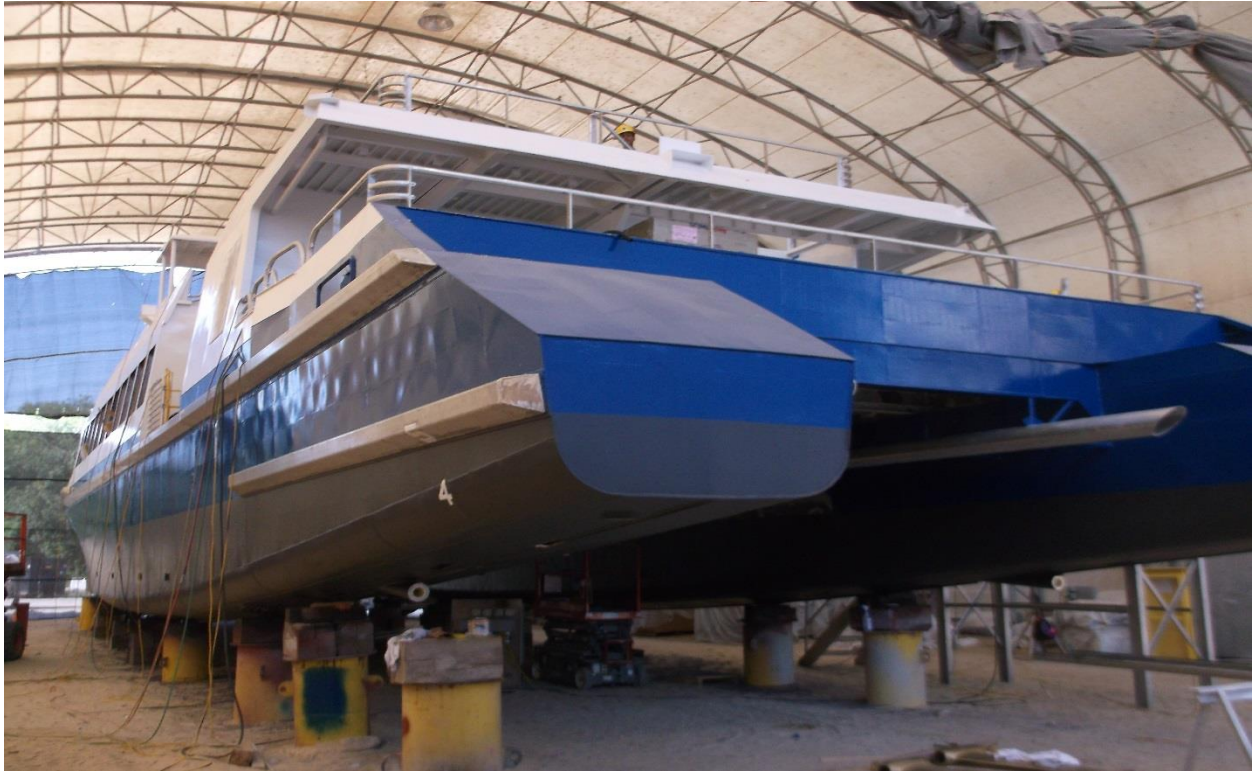
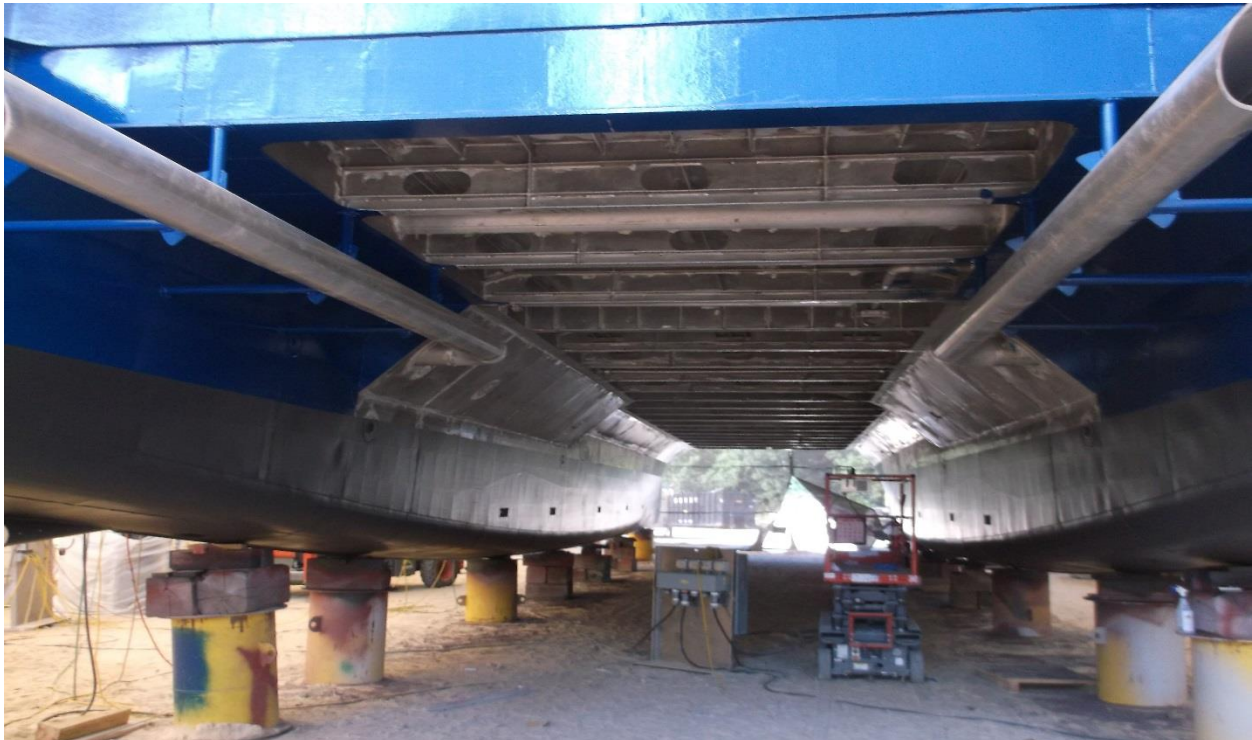
Aft portside and underside views of hull

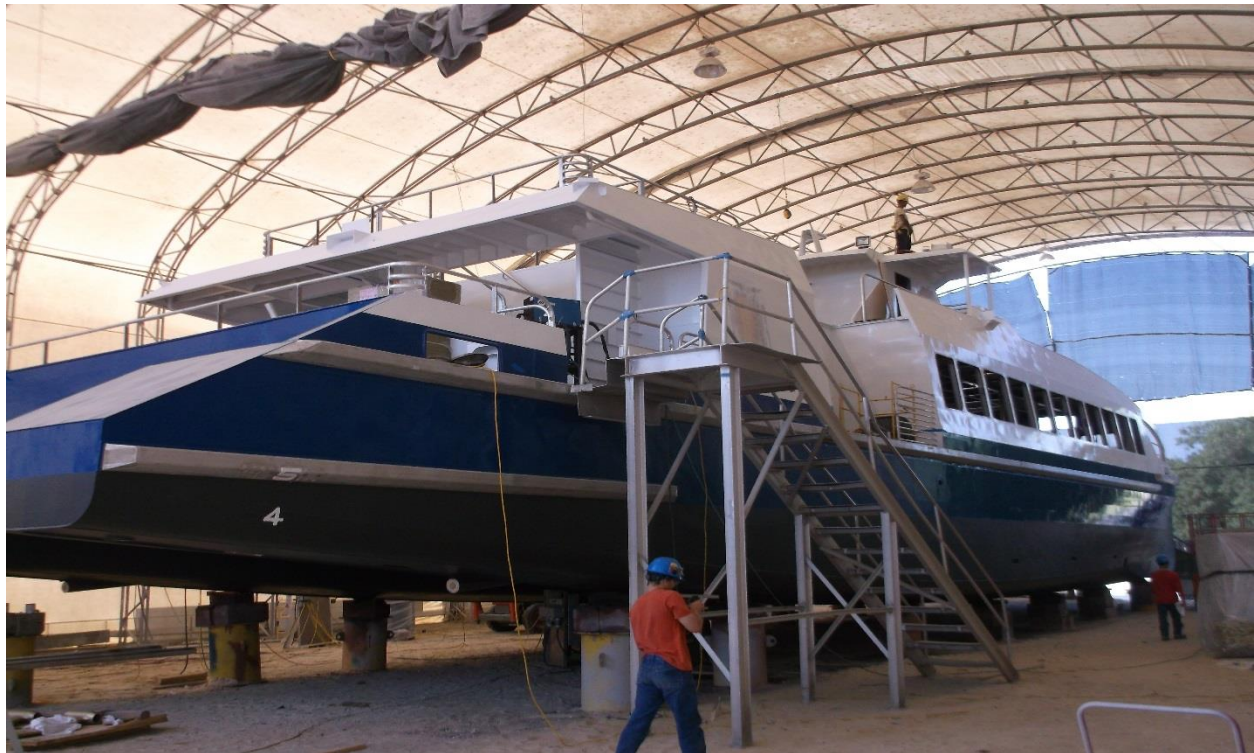
View of aft starboard side

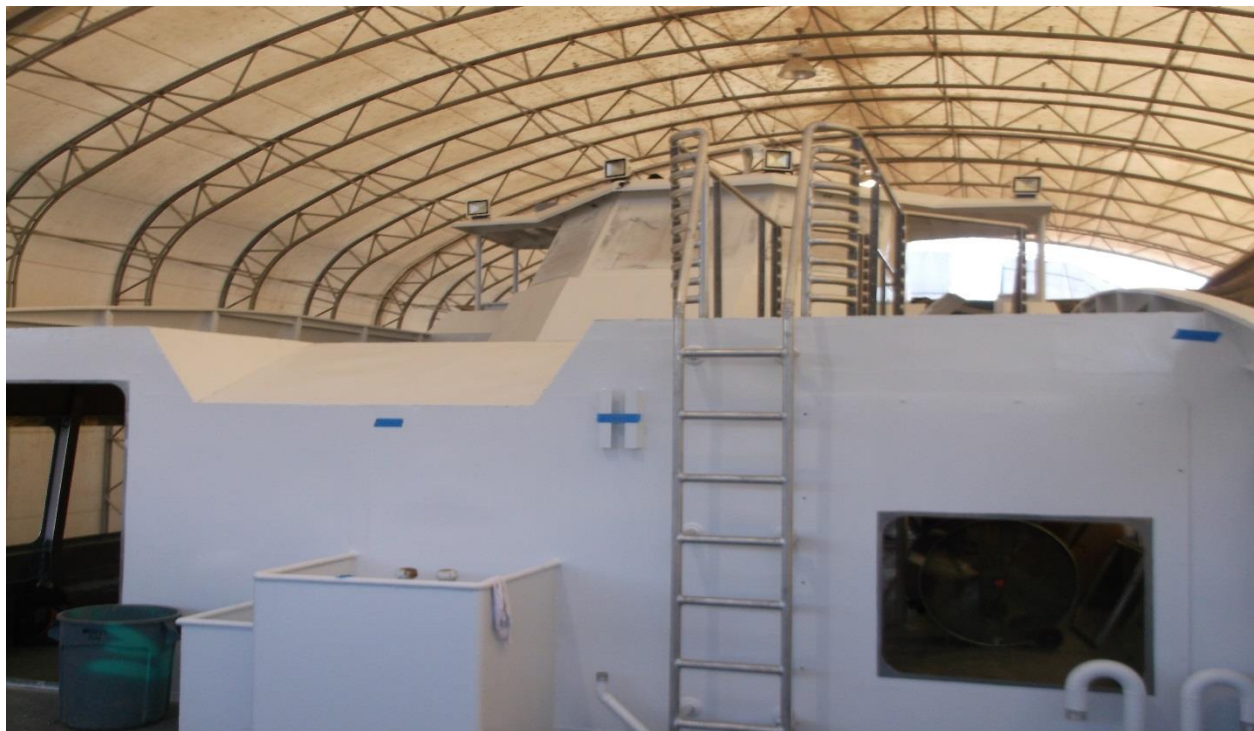
View of forward upper deck

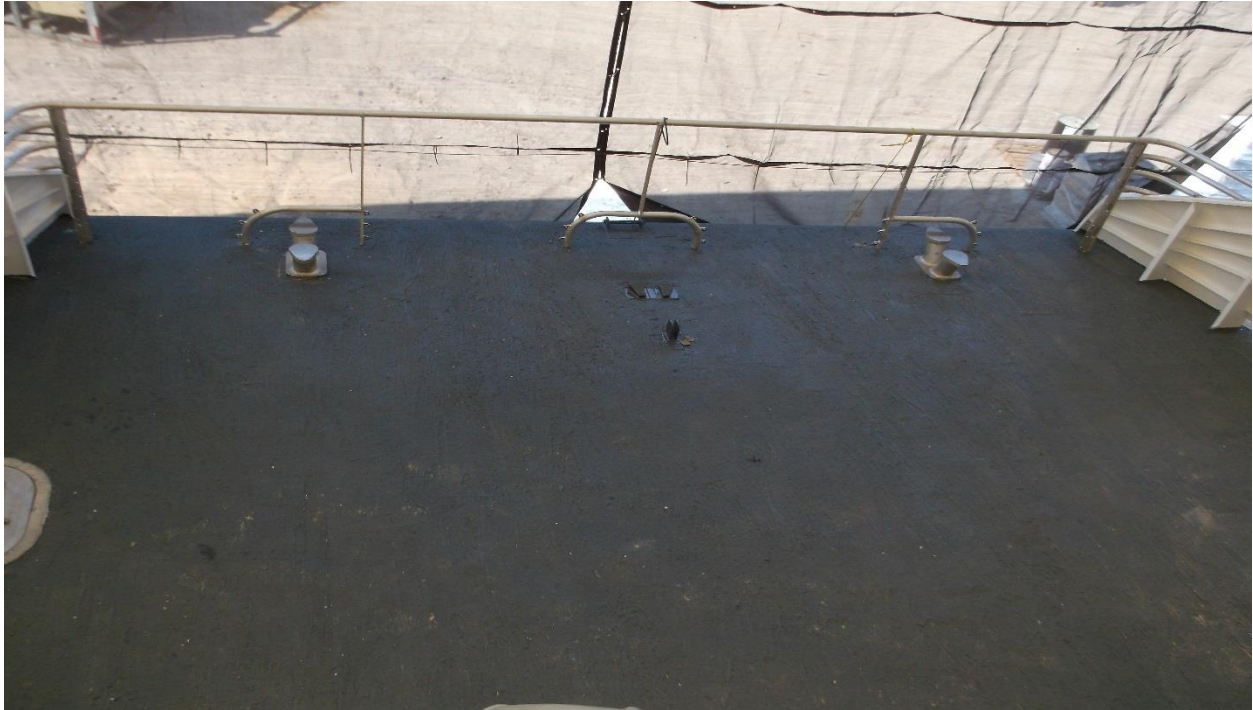
View of forward main deck having nonskid applied

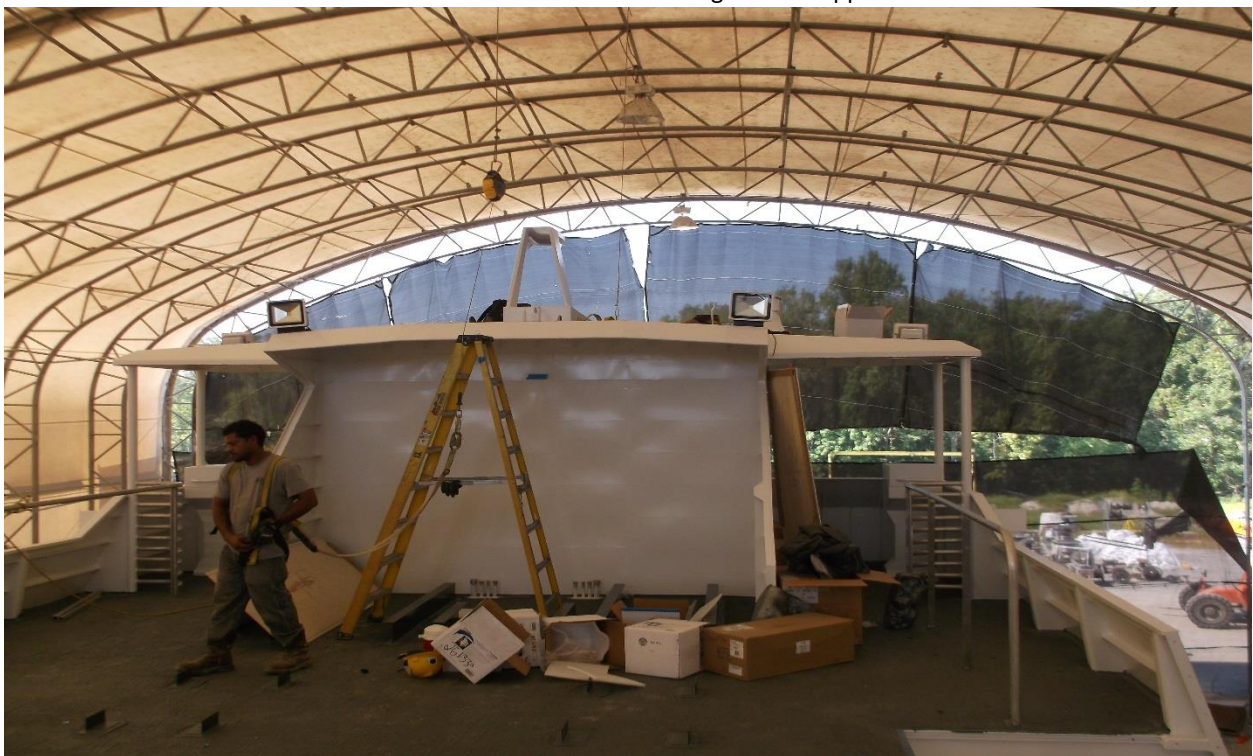
Aft view of upper deck and top of pilothouse having flood lights installed

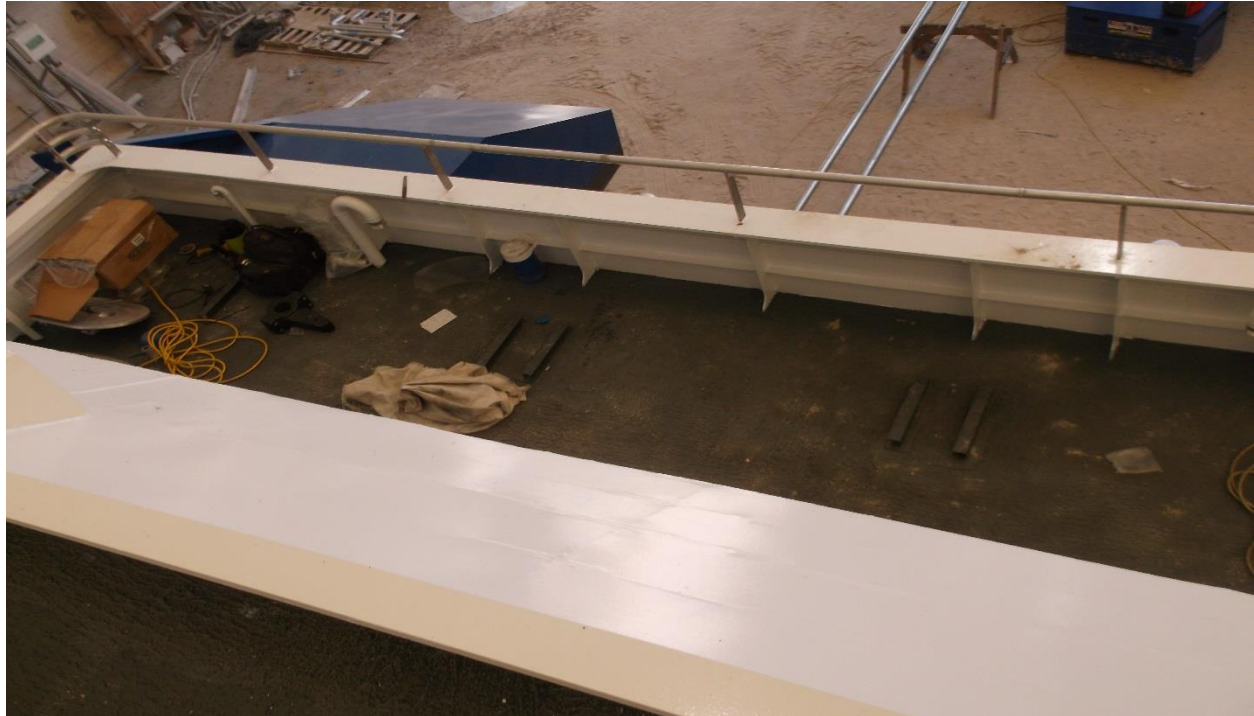
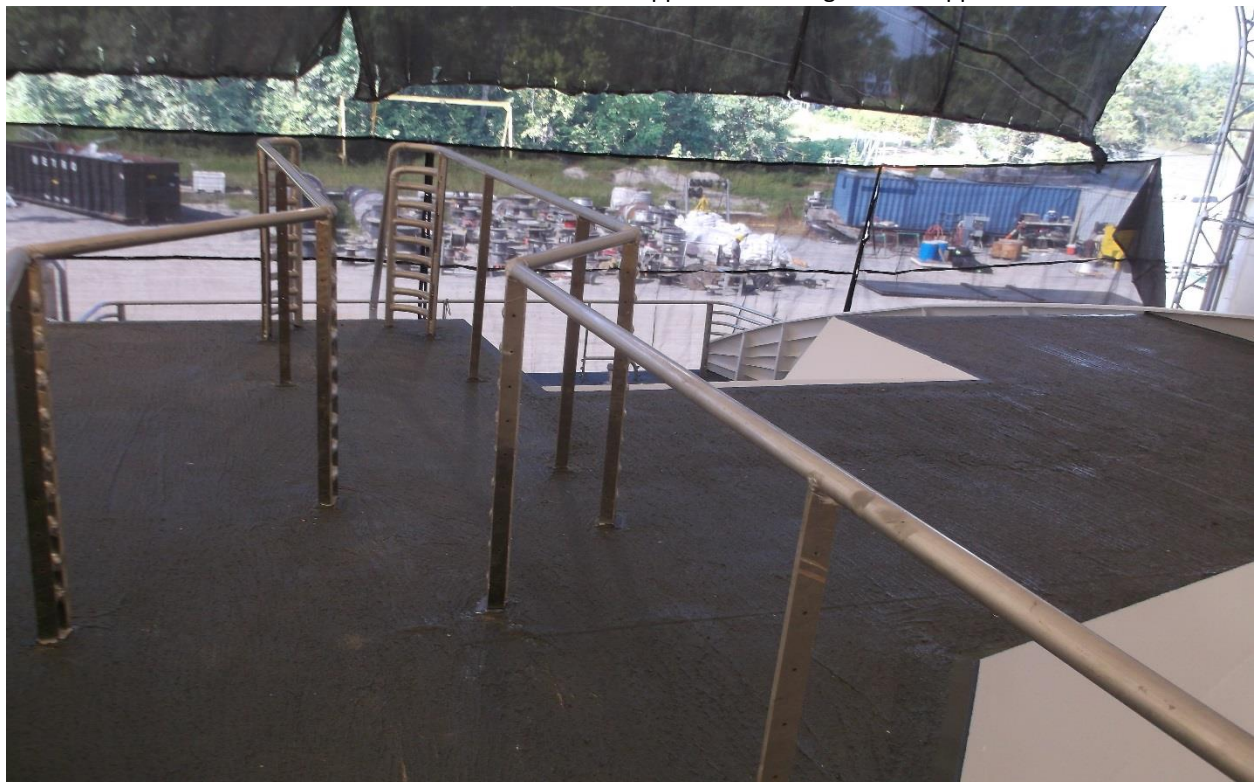
Views of aft main deck and forward upper deck having nonskid applied

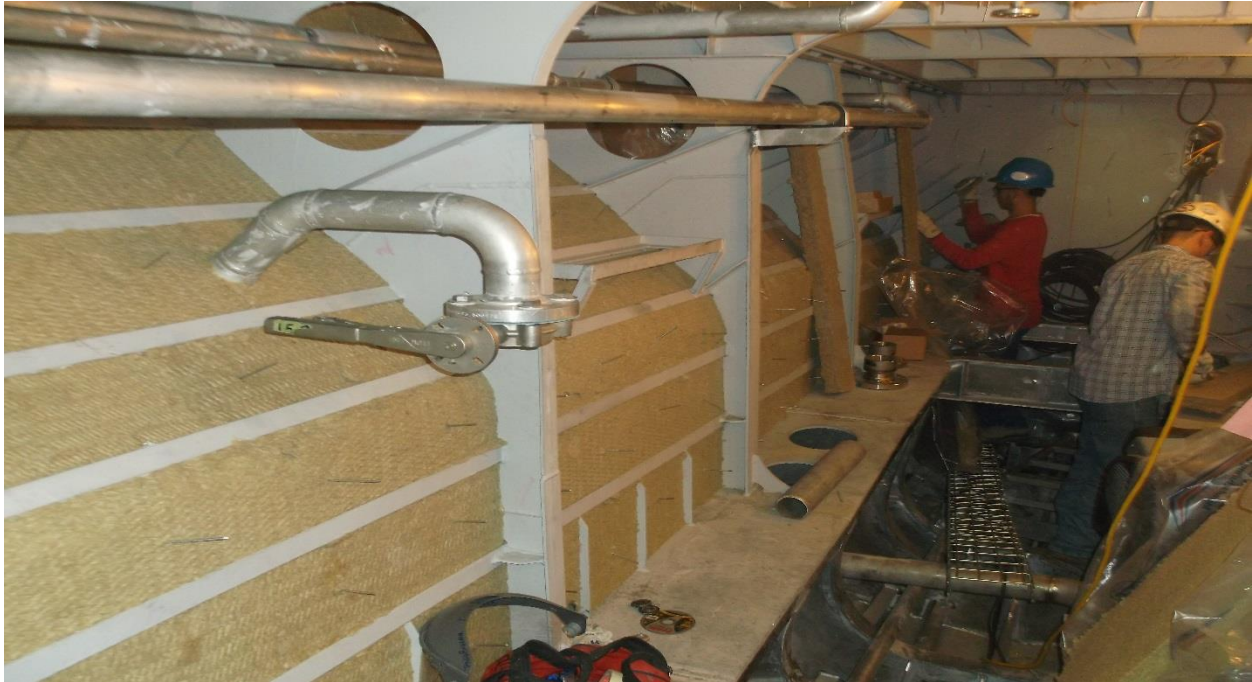
View inside starboard machinery space with insulation installing

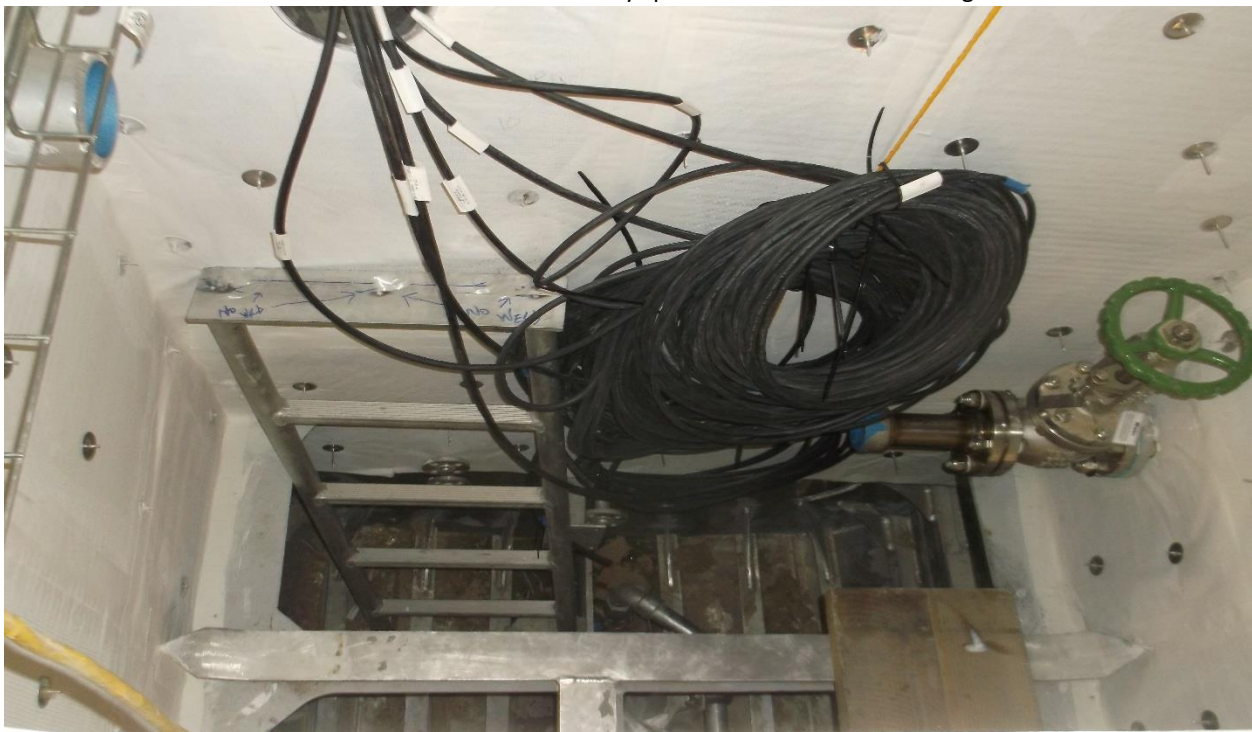
View of forward portside machinery space having insulation coated and some electrical cables pulled and bundled

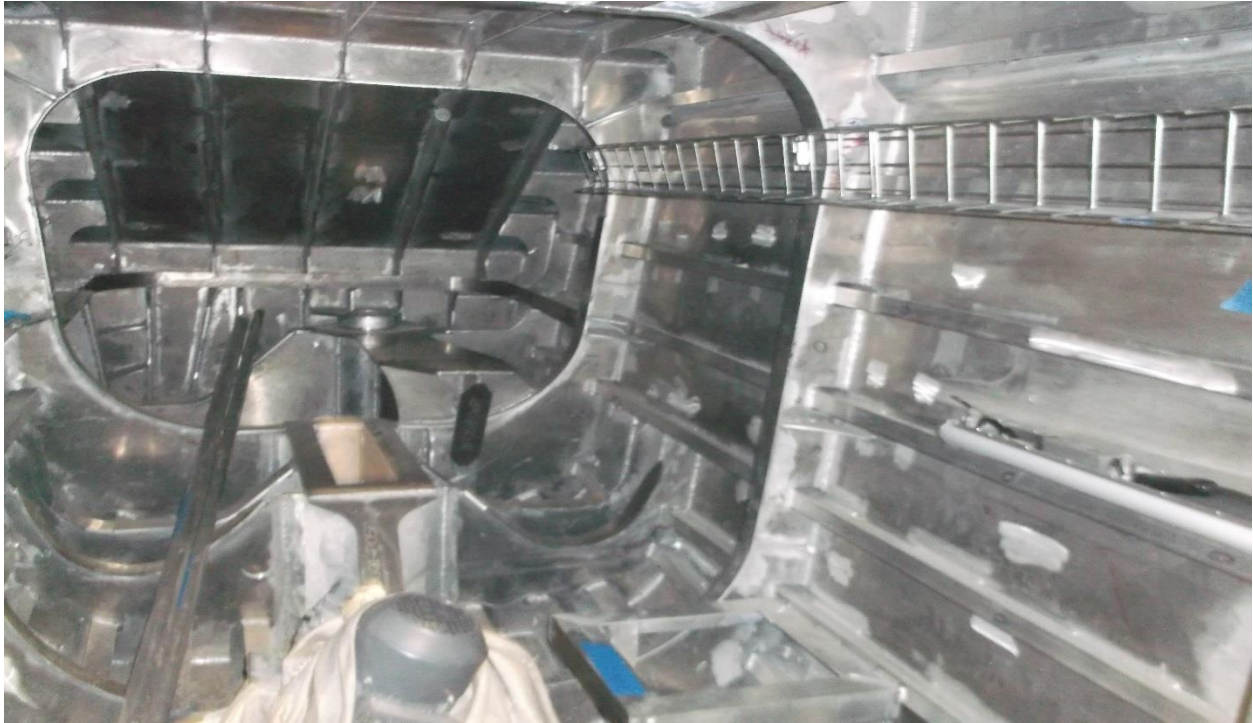
Aft and forward views inside the portside no.5 compartment having cable race ways and tanks set

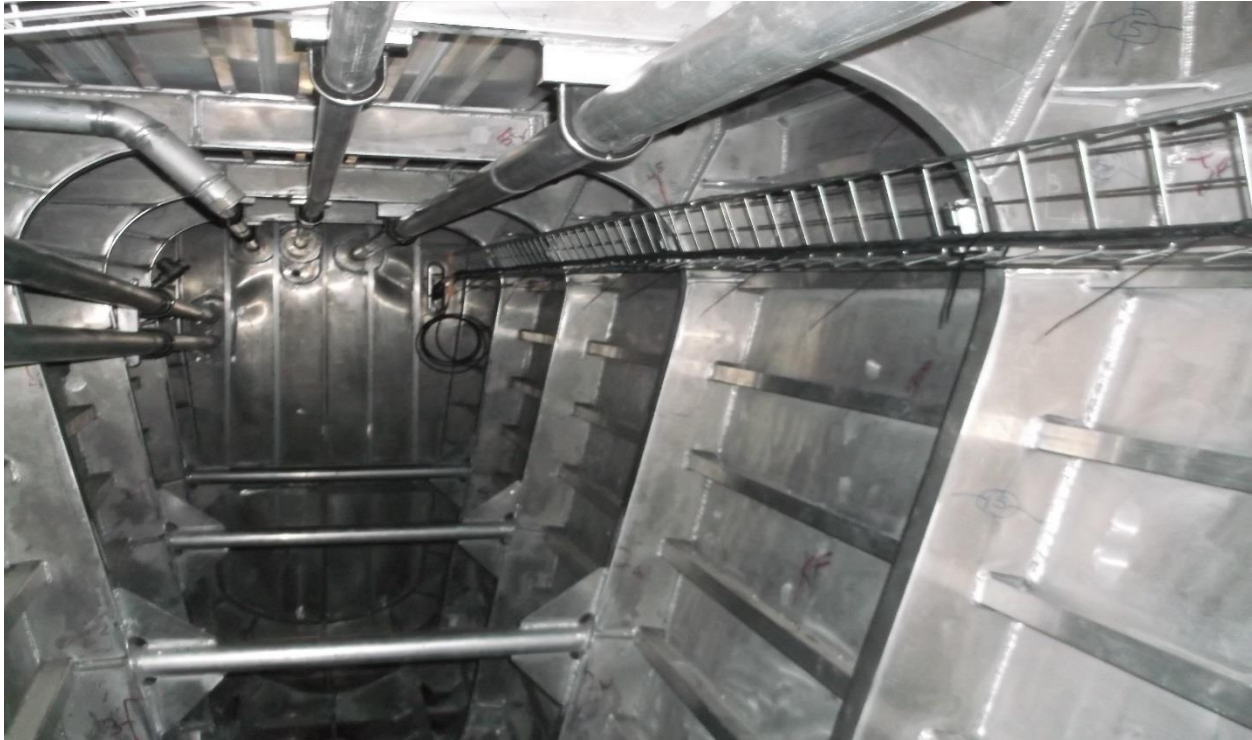
View inside no.2 port and starboard/bow thruster voids having race ways with electrical cables starting to install

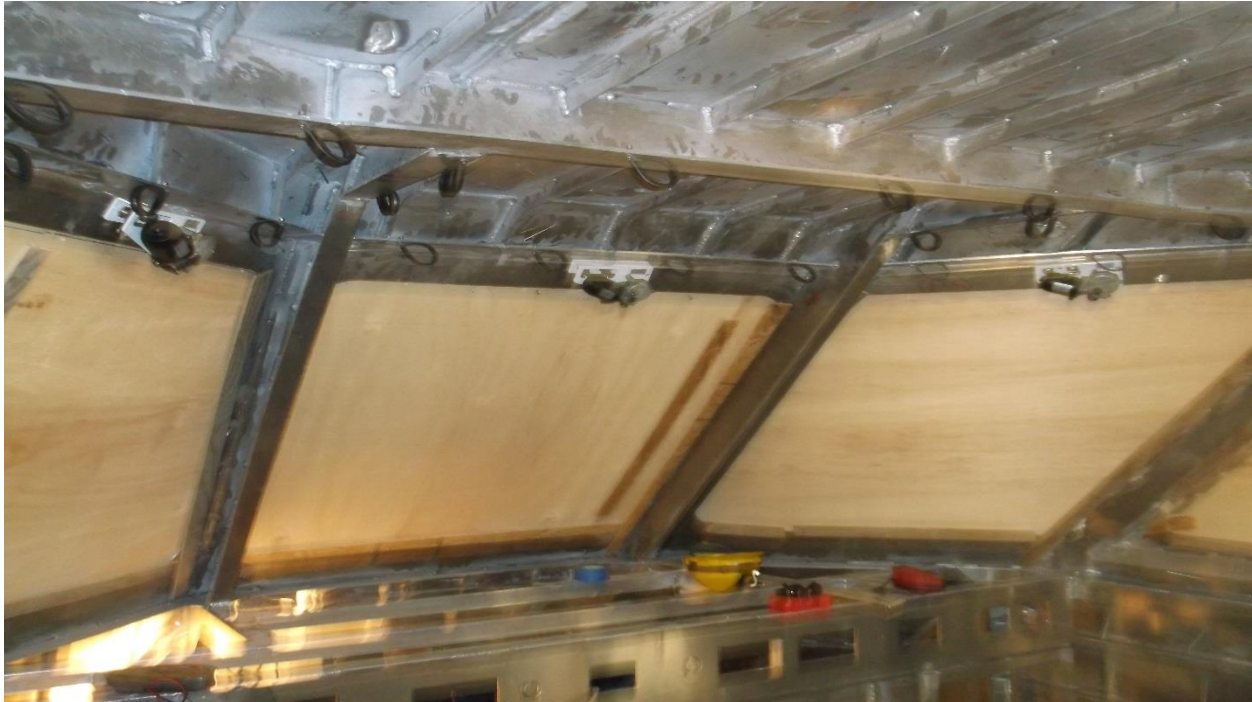
View inside pilothouse having windshield wiper motors and cable clamps installed

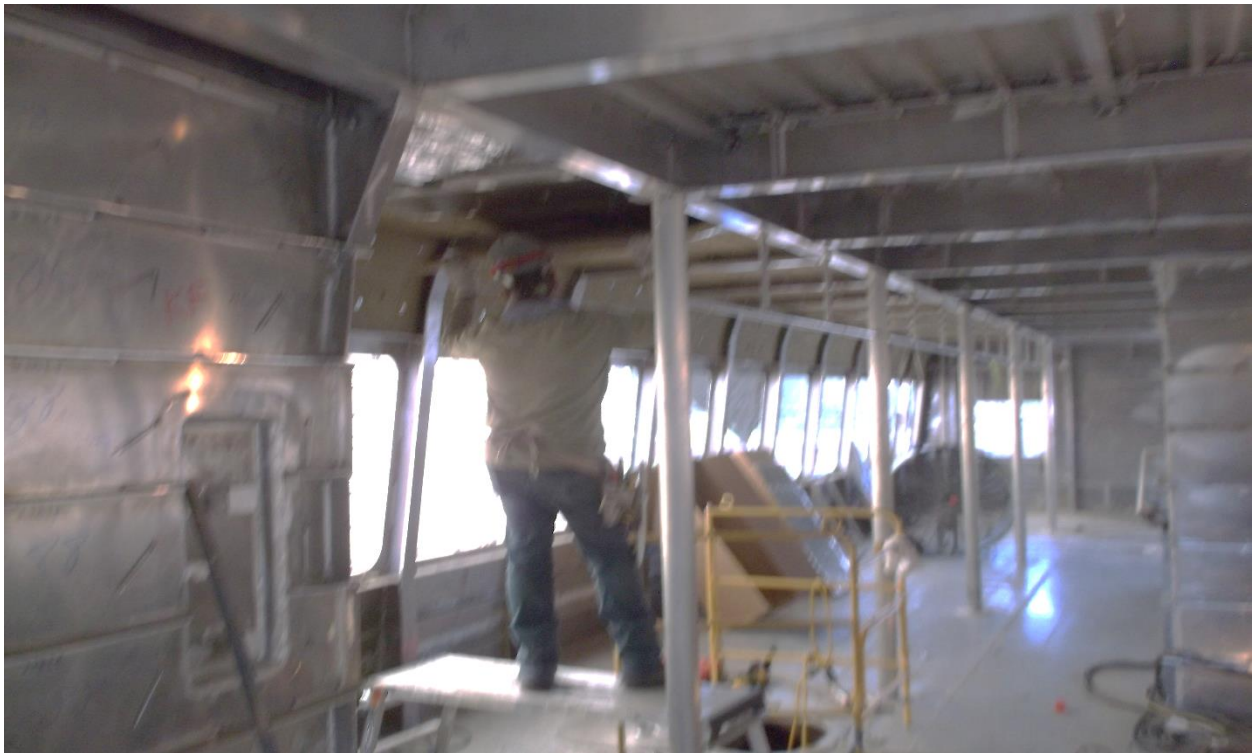
Insulation installing inside deckhouse
